## EVALUATION ROAD DAMAGE USING THE PAVEMENT CONDITION INDEX (PCI) METHOD

Mochammad Ilham<sup>1</sup>, Hanie Teki Tjendani<sup>2</sup>, Jaka Purnama<sup>3</sup>

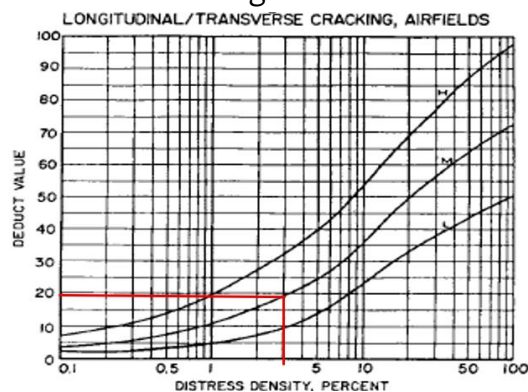
**Figure 2.** DV Graph of Longitudinal/Transverse Crack Damage

Figure 2 shows the graph of deduct value of longitudinal/transverse crack damage is 19.

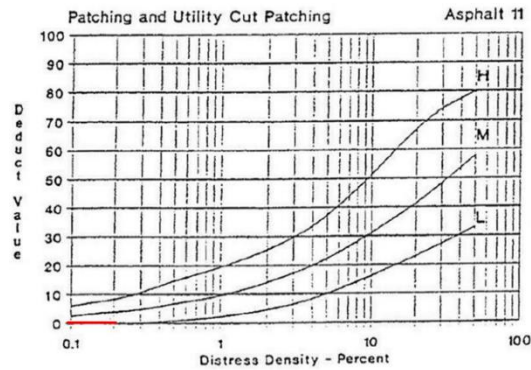
**Figure 3.** Patch Damage DV Graph

Figure 3 shows a graph of the deduct value of patch damage is 0.

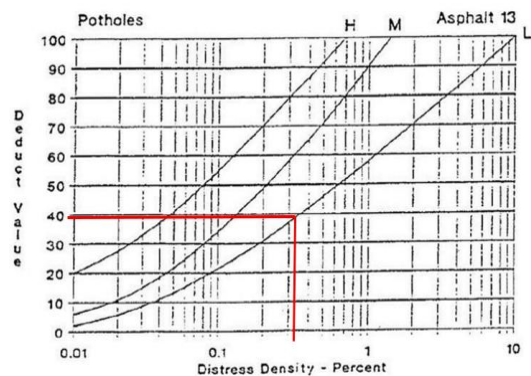
**Figure 4.** Hole Damage DV Graph

Figure 4 shows a graph of the deduct value of hole damage is 39.

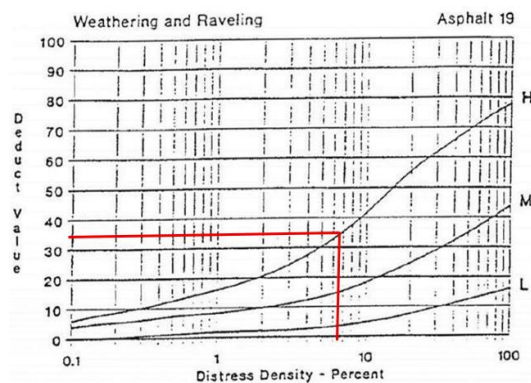
**Figure 5.** Grain Release Damage DV Graph

Figure 5 shows the graph of the deduct value of grain release damage is 35.

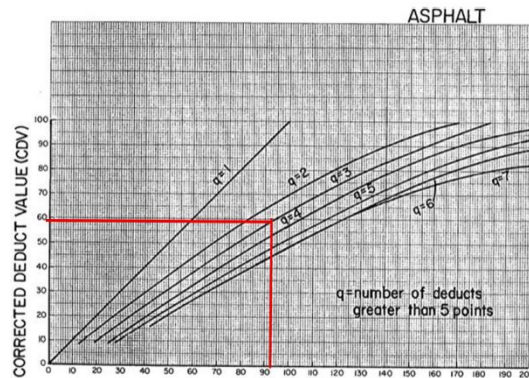
**Figure 6.** Corrected Deduct Value (CDV) STA 0+600-0+800 graph

In the image above, you can see the maximum corrected reduction value (CDV) at STA 0+600-0+800 is 59.

$$\begin{aligned} \text{PCI} &= 100 - \text{CDV}_{\text{max}} \\ &= 100 - 59 \\ &= 41 \text{ poor} \end{aligned}$$

PCI index with a value between 41-55 identifies that the road pavement value at STA 0+600 – 0+800 is categorized as poor. Complete calculations can be presented below as follows.

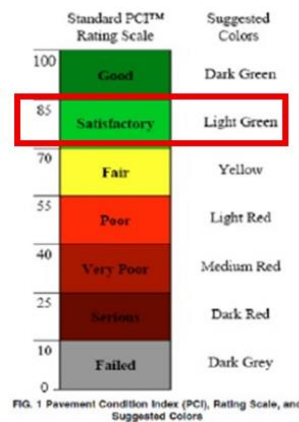
**Figure 7.** Pavement Quality Qualification STA 0+000-1+400

From Table 3 shows the average PCI value is categorized in satisfactory condition because it shows a value of 77.14, where 77.14 is in the range of 70-85 for satisfactory

Figure 7 is a graph showing the PCI STA 0+000-1+400 values that have been generated in calculations using the PCI method. The average value on the Tambakboyo Highway is 77.14 in satisfactory condition.
