## OBSERVATION OF WATER FLOW IN THE BALL VALVE BEFORE AND AFTER REPAIRS USING LAPPING MACHINES

David Tua Armando, Kusdi Prijono

Universitas Pamulang

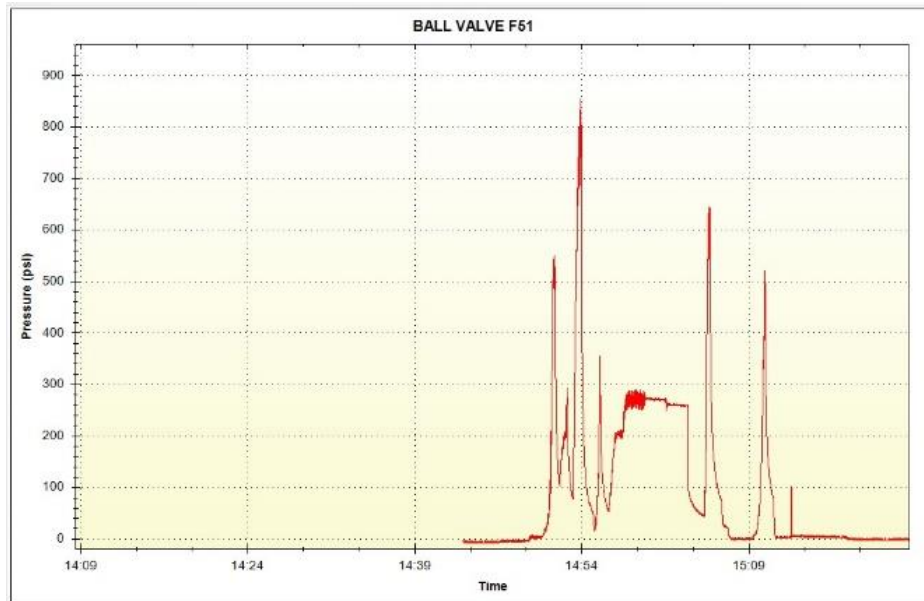
Tests on *ball valves* made of F51 (*duplex stainless steel*) show from the pattern of fluctuations and pressure instability that the *ball valve* has not been able to maintain significant pressure. The graph of the *F51 hydro test ball valve* can be seen in Figure 1.1

**Figure 1. 1** Results Graph *Hydro Test Before Done Lapping At Ball Valve F51*

Yes	Time Interval	Pressure (psi)	Explanation
1	14:09 - 14:40	0	Idle phase, no pressure filling yet.
2	14:40 - 14:45	0 - ±600	The pressure begins to rise sharply, the initial injection phase.
3	14:45 - 14:54	0 - ±300	Extreme fluctuations occur, indications of leakage or unrestrained pressure. Pressure is unstable.
4	14:54-14:56	±850	A brief but untenable surge of pressure occurs
5	14:56 - 15:00	±300 - 0	There was a drastic decrease, followed by replenishment efforts, the pressure remained unstable.

Yes	Time Interval	Pressure (psi)	Explanation
6	15:00 – 15:10	$\pm 250 - 0$	Several refill attempts were made but the pressure always dropped, the ball valve was unable to maintain the test pressure.
7	15:10 – 15:15	0	The pressure no longer appears, the test is completed and the system is emptied

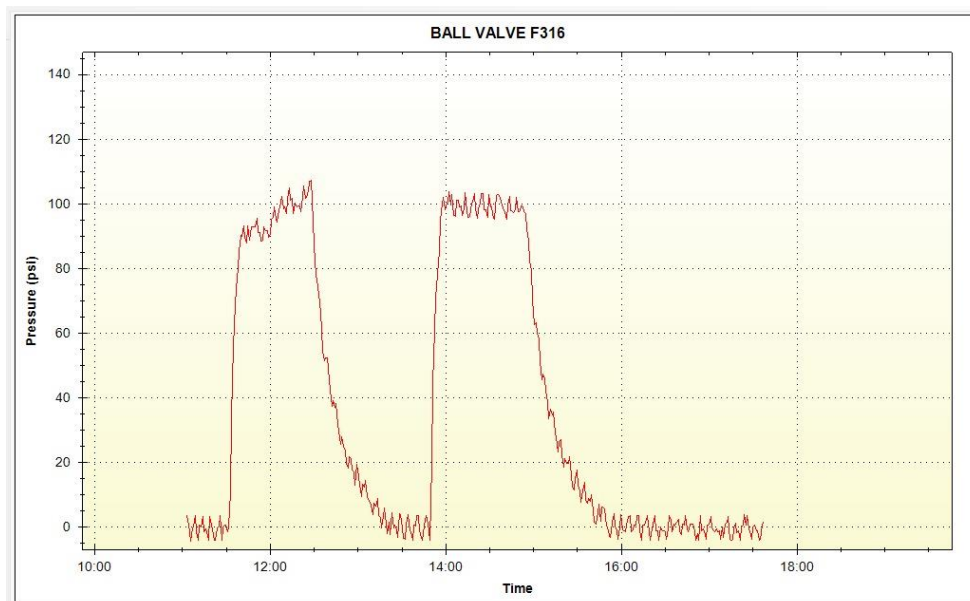
Ball valve F316 (Austenitic Stainless Steel) shows the most stable initial performance compared to the other two materials. The maximum test pressure is in the range of 100 psi, and it can be maintained for a relatively long period of time. This shows the sealing is still working quite well even though it's not perfect. Graphs *Hydro Test Ball Valve F51* can be seen in Figure 1.2.

**Figure 1. 2** Results Graph *Hydro Test Before Done Lapping At Ball Valve F316*

Yes	Time Interval	Pressure (psi)	Explanation
1	10:00 – 11:50	0	No testing, no pressure yet
2	11:50 – 12:00	0 - $\pm 100$	The pressure increases rapidly, but only reaches $\pm 100$ psi

Yes	Time Interval	Pressure (psi)	Explanation
3	12:00 – 12:30	$\pm 100 - 0$	Direct pressure drops rapidly, indicating a leak or the ball valve's inability to withstand pressure
4	12:30 – 13:50	0	No pressure
5	13:50 – 14:00	$0 - \pm 100$	A second test was performed, again only reaching $\pm 100$ psi
6	14:00 – 15:30	$\pm 100 - 0$	The pattern of pressure drop repeats very quickly drastically
7	15:30 – 18:00	0	The pressure no longer appears, the test is completed and the system is emptied.

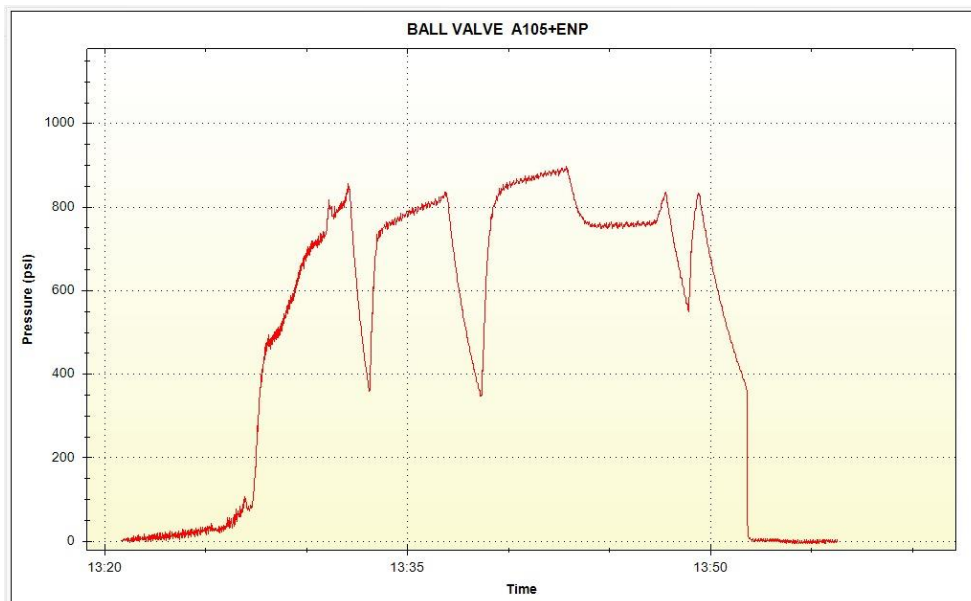
The *ball valve* material A105ENP (carbon steel) shows the ability to achieve the highest pressure among the three materials, which is up to  $\pm 850$  psi. However, the graph shows very unstable pressure fluctuations, with repeated sharp drops, indicating indications of leakage in the *sealing*. The graph of the results of the hydro test ball valve can A105ENP be seen in Figure 1.3.

**Figure 1. 3** Results Graph *Hydro Test Before Done Lapping At Ball Valve*  
A105ENP

Yes	Time Interval	Pressure (psi)	Explanation
1	13:20 - 13:27	0 - $\pm 200$	Initial charging, the pressure begins to rise gradually
2	13:27 - 13:30	$\pm 200$ - $\pm 850$	The pressure increases significantly, approaching the maximum value.
3	13:30 - 13:31	$\pm 850$ - $\pm 300$	The first drastic drop in pressure, indicates indications of leakage.
4	13:31 - 13:34	$\pm 300$ - $\pm 850$	The pressure is constantly rising.
5	13:34 - 13:35	$\pm 850$ - $\pm 350$	A second pressure drop, similar to the previous event
6	13:35 - 13:38	$\pm 350$ - $\pm 850$	Pressure increased again
7	13:38 - 13:40	$\pm 850$ - $\pm 700$	The pressure has decreased slightly but not drastically.
8	13:40 - 13:42	$\pm 700$ - $\pm 850$	The pressure is again raised.
9	13:42 - 13:45	$\pm 850$ - $\pm 400$	The pressure drop is sharp, but a little slower than before.
10	13:45 - 13:50	$\pm 400$ - 0	Pressure gradually drops to exhaust, testing ends

11	13:50 - 13:53	0	There is no pressure, a flat graph signals the end of a test.

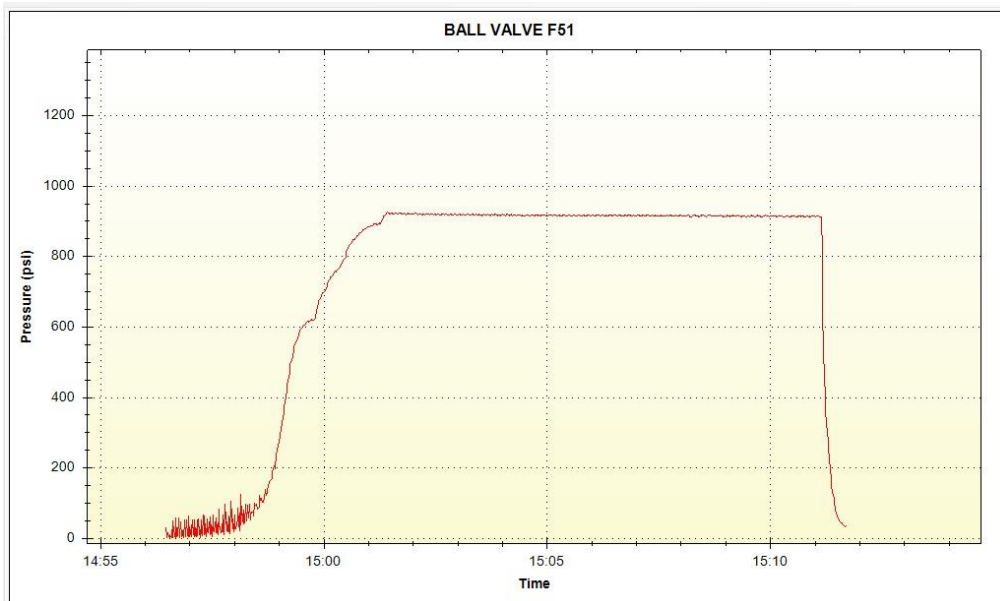
In the F51 ball valve material, the *hydro test* graph shows that after the repair process using a *lapping machine*, the performance of the ball valve has significantly improved. The pressure is able to reach a maximum of  $\pm 920$  psi without any drop, meaning it lasts for 15 minutes during the *holding test* period. This shows that the *lapping* process successfully restored the sealing ability of the F51 ball valve. The graph of the results of the *hydro test* ball valve F51 can be seen in Figure 1.4

**Figure 1. 4** Results Graph *Hydro Test After Done Lapping At Ball Valve F51*

Yes	Time Interval	Pressure (psi)	Explanation
1	14:55 – 14:58	0 - $\pm 200$	At the beginning of water injection ( <i>pre-loading</i> ), there is a gradual formation of pressure, accompanied by air stability in the system
2	14:58 – 15:00	$\pm 850$	The pressure increases rapidly and indicates the closed system is working optimally. Cannot leak when pressure rises
3	15:00 – 15:10	$\pm 920$	Holding phase. The pressure is maintained $\pm 10$ min without a decrease means the pressure is stable. This signifies the sealing is working well and there are no leaks
4	15:10 – 15:12	0	Pressure drop is performed at the end of the test ( <i>decompression</i> ), ending the test session complete.

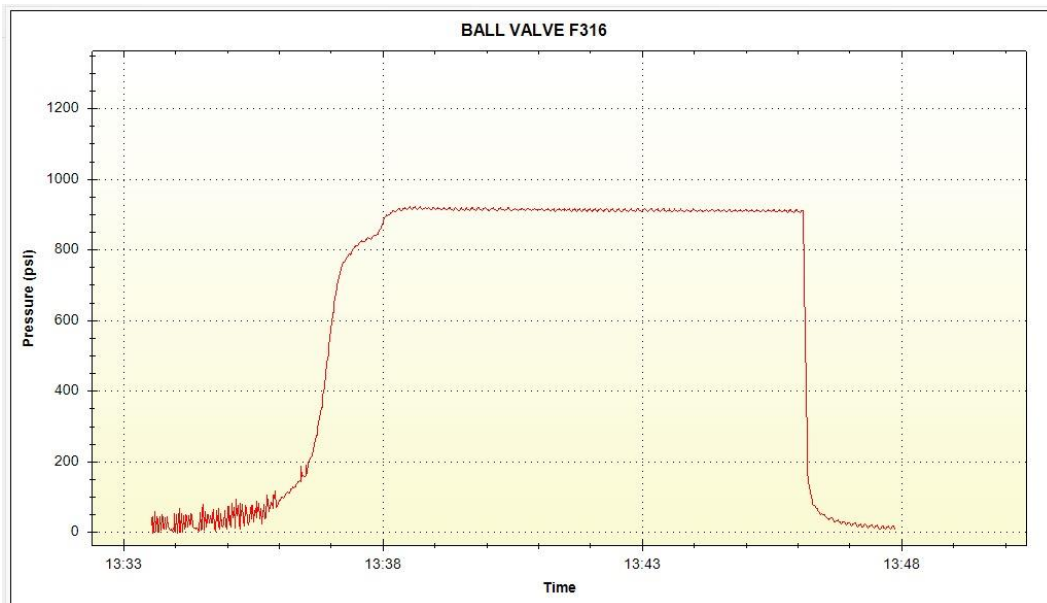
On the material *Ball Valve F316*, graphics *Hydro Test* indicates that after the repair process using the machine *Lapping* shows excellent performance. In the *Holding Time*, the stable pressure reaches a maximum figure of  $\pm 900$  lasting for 15 minutes, indicating that no leakage occurred during the test period. Results graph *Hydro Test Ball Valve F316* can be seen in the Figure. 1.5

**Figure 1. 5** Results Graph *Hydro Test* After Done *Lapping* At *Ball Valve F316*

Yes	Time Interval	Pressure (psi)	Explanation
1	14:50 - 14:53	0 - $\pm 250$	Initial charging phase. The pressure begins to form the stability of the system with a slow increase
2	14:53 - 14:56	$\pm 850$	The pressure increases $\pm 850$ psi, the system reaches optimal. No fluctuations or leaks
3	14:56 - 15:06	$\pm 900$	Pressure stable, <i>sealing ball</i> and seat work well. Stable pressure in the <i>holding</i> phase indicates effective <i>lapping</i> repair results

4	15:06 - 15:08	0	Pressure drop, pressure process (decompression), end of the test session
---	---------------	---	--

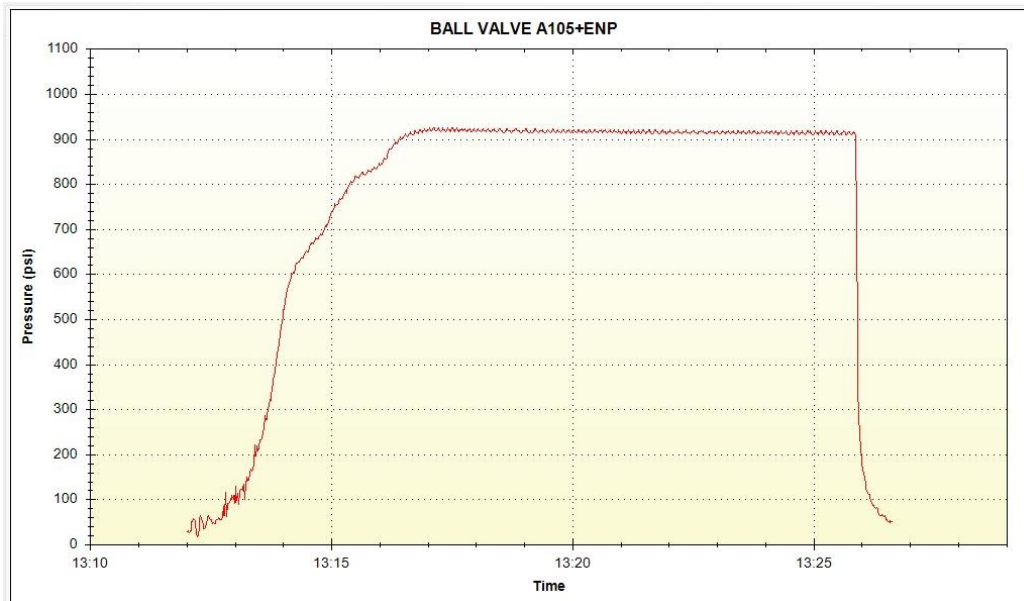
The ball valve A105ENP which previously had an indication of pressure instability, after being fixed using a lapping machine, showed a stable pressure pattern. The maximum pressure is reached at  $\pm 910$  psi and lasts for  $\pm 10$  minutes before pressure release. The graph of the results of the hydro test ball valve can A105ENP be seen in Figure 1.6

**Figure 1. 6** Results Graph *Hydro Test After Done Lapping At Ball Valve*  
A105ENP

Yes	Time Interval	Pressure (psi)	Explanation
1	14:45 - 14:48	$\pm 200$	Initial water refill. There is a gradual formation of pressure, accompanied by air stability in the system.
2	14:48 - 14:51	$\pm 910$	The pressure rises quickly and the system shows a good response. No pressure drop
3	14:51 - 15:01	$\pm 910$	Holding pressure stable. This is proof that the surface of the sealing ball valve has been

Yes	Time Interval	Pressure (psi)	Explanation
			effectively repaired by the <i>lapping</i> process.
4	15:01 – 15:03	0	Pressure drops, pressure process ( <i>decompression</i> ), ends the testing session.

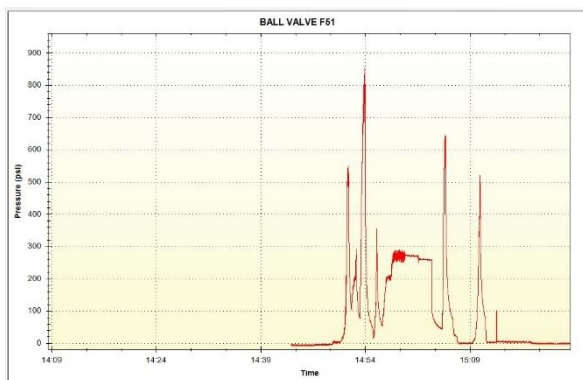
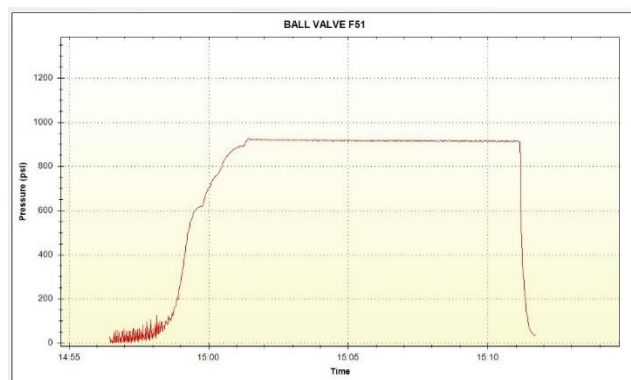
Before the *lapping* repair, the ball valve F51 showed an unstable pressure pattern. The *hydro test* graph will most likely show a significant drop in pressure during the *holding* phase, indicating a leak between the *ball* and the *seat*. Prior to *lapping*, the ball valve F51 showed an unstable pressure pattern where at the beginning the pressure rose sharply at  $\pm 600$  psi, decreased at  $\pm 300$  psi, rose at  $\pm 850$  psi, there was a drastic drop at  $\pm 300$  psi, and at  $\pm 250$  psi the *ball valve* was unable to maintain the test pressure. This decrease indicates the valve's failure to maintain pressure according to the standard.

However, after the repair, there was a drastic change in the pattern. Based on the data from Table 1.5, the post-repair graph shows a steady pressure increase from 0 to  $\pm 920$  psi. The key pattern observed is a steady pressure at  $\pm 920$  psi for 15 minutes (*holding* phase) without any fluctuations or decreases. This proves that the *lapping* process successfully creates a perfect *sealing surface*, eliminates leaks, and restores valve function.

**Figure 1. 7** (a) Pressure Pattern Before Being Exposed *Lapping* (b) Pressure Pattern After At *Lapping* Ball Valve F51

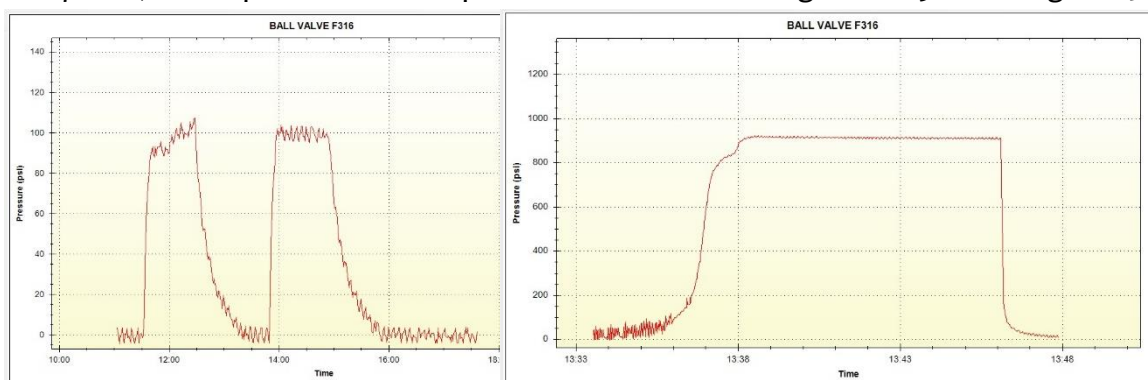
Similar to the F51, prior to the repair, the ball valve F316 also showed an inability to maintain the test pressure, as evidenced by a graph showing a gradual or rapid decrease

in pressure. This pressure drop can be slower or faster, depending on the initial degree of damage to the *sealing surface*. In the *ball valve F316* the pressure increases rapidly, but only reaches  $\pm 100$  psi, the direct pressure drops rapidly at 0 psi indicates the presence of a leak or incapacitation of the *ball valve*, a second test is performed, only reaching  $\pm 100$ psi, and the pressure drop pattern repeats very quickly again drastically at 0 psi indicating the maximum test pressure is only around  $\pm 100$ psi.

After the *lapping improvement*, the pressure pattern on the F316 changed to stable, similar to that of the F51. The chart will show the pressure increase to the optimal value, followed by the *holding phase* where the pressure is successfully maintained constantly without leakage. This change in pattern from decline to stability underscores the effectiveness of the *lapping method* for F316 materials. *Ball valve F316* in the *holding time phase*, stable pressure from 0 psi reaches a maximum figure of  $\pm 900$  lasting for 15 minutes.

**Figure 1. 8** (a) Pressure Pattern Before Being Exposed *Lapping* (b) Pressure Pattern After At *Lapping Ball Valve F316*

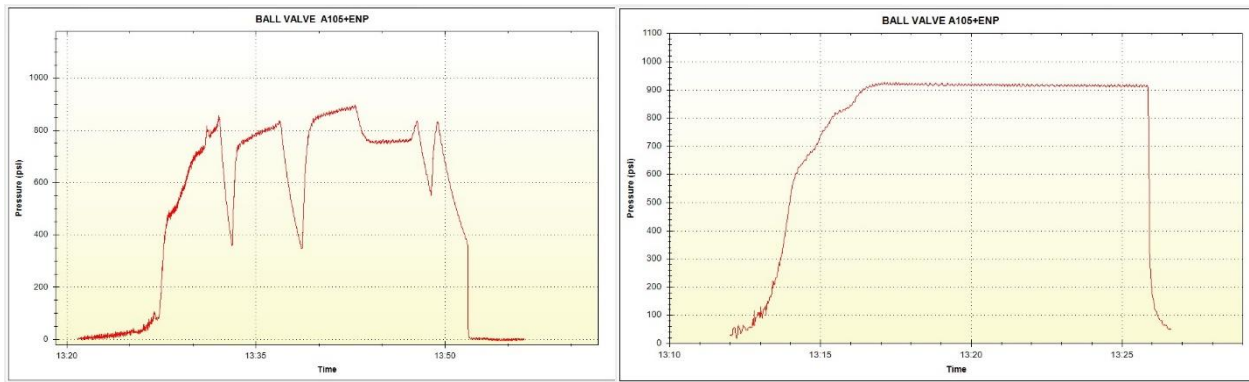
Before repair, the ball valve A105ENP also not able to maintain the test pressure. The *hydro test graph* will show a decrease in pressure during the *holding phase*, indicating a failure in the *sealing function*.

After repair, the pressure pattern changes significantly. Based on the data in Table 1.5, this valve successfully reached and maintained a pressure of  $\pm 910$  psi for 15 minutes (*holding phase*). The explanation of the *sealing ball and the seat* working well confirms that the *lapping repair* has succeeded in creating precise surface contact, thus preventing leakage. This pattern proves that the corrective method applied is effective for *ball valves A105ENP*.

**Figure 1. 9** (a) Pressure Pattern Before Being Exposed *Lapping* (b) Pressure Pattern After At *Lapping* Ball Valve A105ENP
